## EXECUTIVE SUMMARY

At the request of Ohio Realty Advisors (ORA) in Richfield, OH, Mountain Sky Group, LLC (MSG) performed a Phase I Environmental Site Assessment (ESA) in general conformance with the scope and limitations of the ASTM International (ASTM) Standard Practice for Environmental Site Assessments: Phase I Environmental Site Assessment Process (E1527-05) for the 87 acre Hoover Company site (the Site) in the North Canton, Stark County, Ohio. The Site includes all portions of the Hoover Company facility that is a household vacuum cleaner and steam cleaner manufacturing facility, located at 101 East Maple Street, North Canton, OH. Any exceptions to, or deletions from, this practice are described in Section 1.1.4 of this report. In addition to the ASTM standard requirements that are met by this report, it also addresses several other scope items including:

The Site consists of approximately 87 total acres of land with approximately 25 acres of manufacturing and warehouse buildings and the remaining 62 acres being outside storage, parking space and outdoor recreation space, in North Canton, OH (Figures 2 and 3). It includes one large warehouse building (Bldg. 36, ~199,100 s

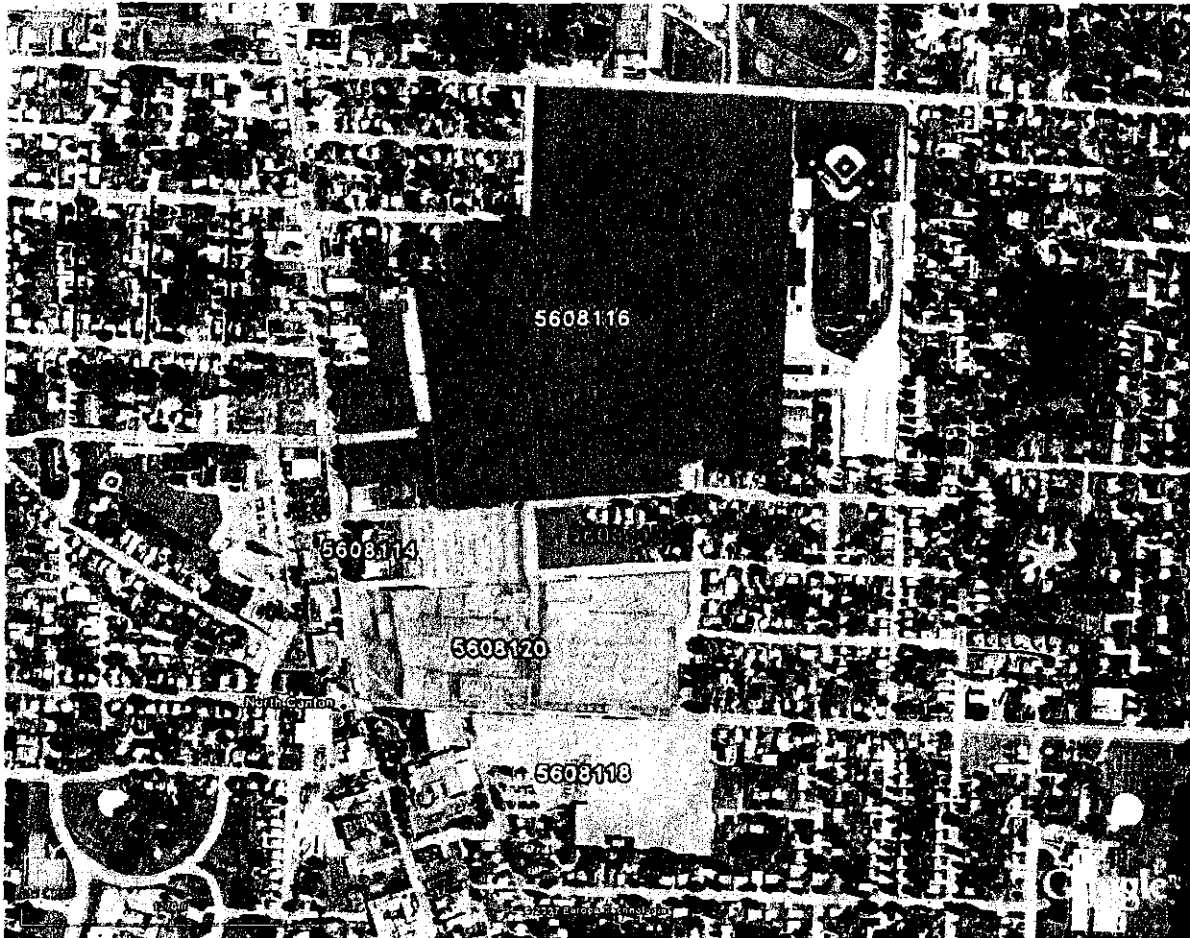
Figure 2 – The Site showing the legal parcels

Stark County records obtained through the Stark County Auditors office and communication with Mr. Judkins (as well as Ms. Mary Shoening – Legal Counsel for TTI) have indicated that the Site is divided into five (5) legal parcels (Figure 2 below). The parcel numbers for each parcel and the Stark County web site where they can be found are:

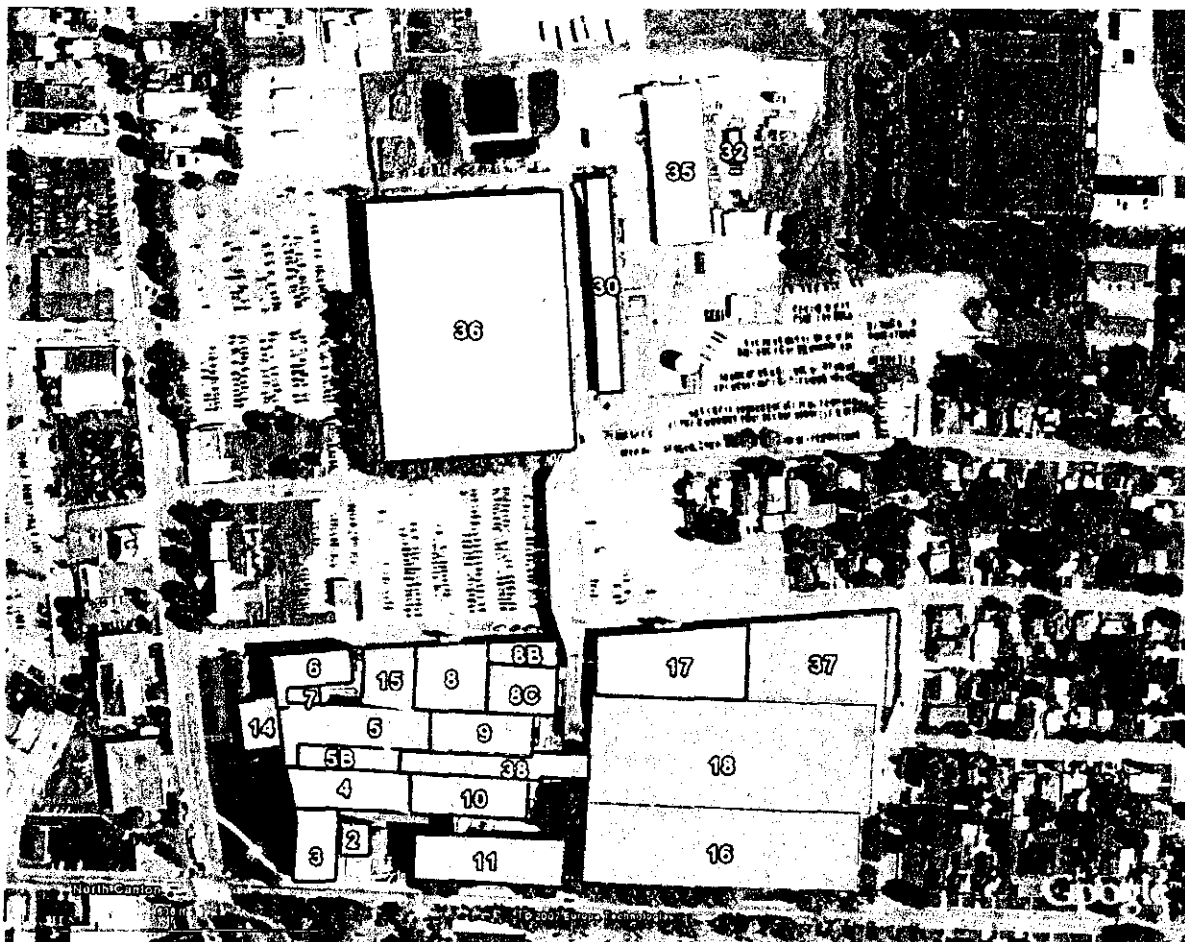
Figure 3 – Building Locations

- ◆ Wetlands – There is one wetland area identified through the EDR state of Ohio wetlands database on the Site. This wetland if present would be located directly underneath the oldest manufacturing building on the Site (Figures 1 - 3). MSG suspects that there is a problem with the depiction on the state database. No wetlands areas were observed on the property or indicated by National Wetlands Inventory.
